Acutec Home Inspectors  
Shawn Gregg  
LHI# 10724

# Home Inspection Report

123 Main Street  
Small Town, La 70000

**Company Address** P.O. Box 93  
**City** Slidell **State** LA **Zip** 70459  
**Phone** 985-290-8993  
**E-Mail** Shawn@AcutecLLC.com  
**Report Name** New Construction Problems  
**Payment Amount:** 400  
**Payment Method:** Paypal Invoice

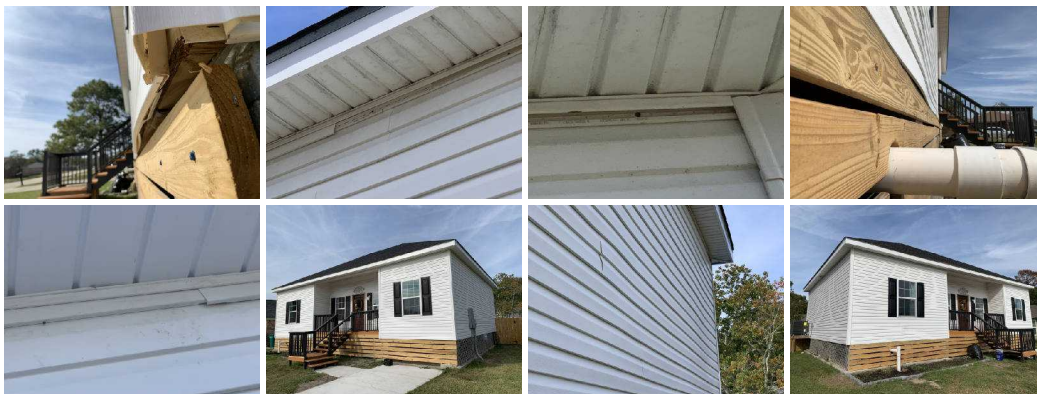
- 1. **Foundation type: Cement: Blocks:** Concrete block
- 2. **Siding type: Vinyl:**
- 3. Marginal **Foundation:** Partially visible/ inspected - The structure did not appear to be level. Further evaluation and repair by a licensed contractor is recommended.
- 4. Defective **Vinyl Siding:** Loose and warped components noted. Questionable installation practices and Exposed fasteners noted. There were moisture stains partially visible on the wood behind the siding.

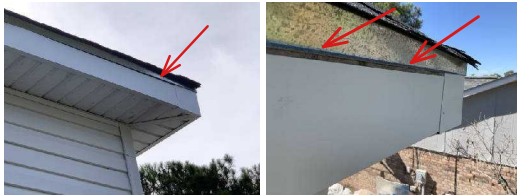
5. Defective

**Fascia:** Incorrect installation noted. The fascia was not tall enough to tuck behind the drip edge flashing at the roof line. Water entry and damage was suspected.

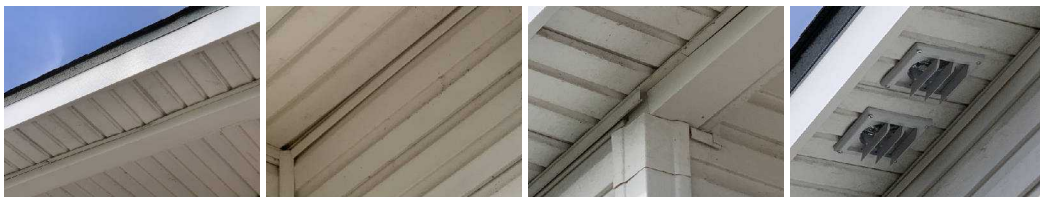
6. Defective

**Soffits:** Improper soffit vent assemblies installed. These self closing louvers are designed for vertical wall applications as the vents hang open. Replace with correct components.

Warped components and nonstandard trim practices noted.

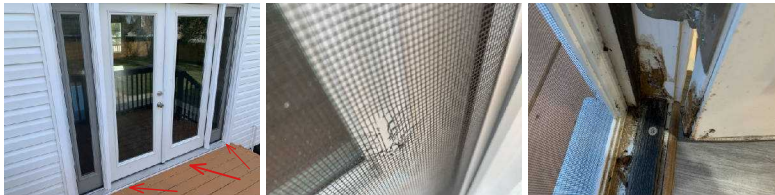
10. Defective

Damaged screen noted.

Moisture staining and deterioration present.

The vinyl trim under the threshold concealed any flashing installed between the structure and the ledger board. No flashing was visible and there were signs of water leaking down into the concealed components below.

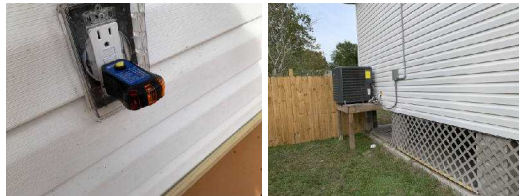
**Outlets:** GFCI protected.

There was no electrical outlet near the AC unit for servicing.

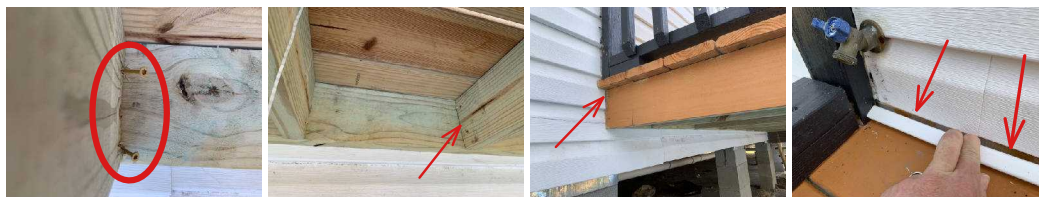
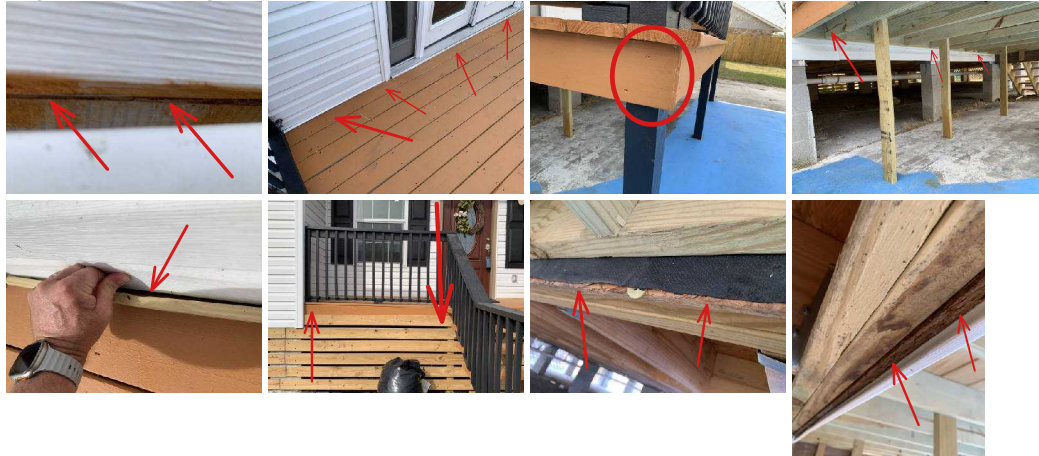
15. Defective

**Porch / Patio:** There did not appear to be a proper flashing where the ledger board attached to the structure at the front and rear porch areas. Wood and vinyl trim was installed, mostly concealing these areas of concern. Proper, adequate hardware and method of installation could not be confirmed.

The exterior weatherproofing wrap was cut and appeared to allow water to leak and cause stains and to partially concealed components. Damage and organic growth are suspected within the exterior and interior components. The wood subfloor under the vinyl plank flooring was moisture stained.

The structures did not appear to be level.

The deck steps, railing and fasteners did not appear to me current building standards.

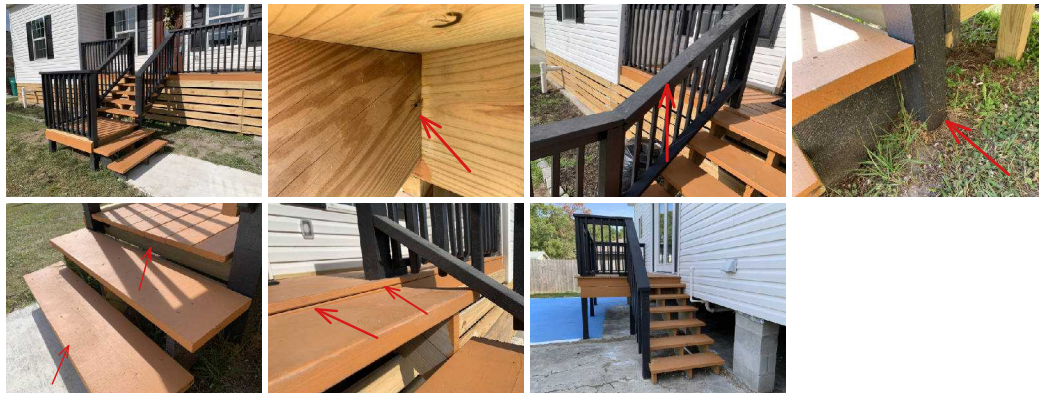
16. Defective

**Steps:** The steps did not appear to be up to current standards. Further evaluation and repair by a licensed contractor is recommended.

The railings were not graspable or high enough in areas, the tread depth/rise did not appear to be consistent, the steps were not level, Open backs above 30 inches, etc.

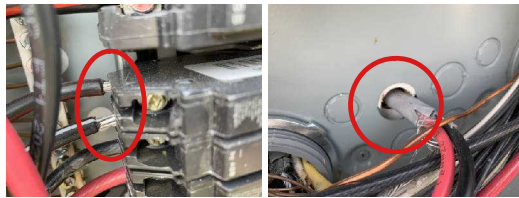
11. Defective

The protective insulation was cut back too far, beyond the arc shield on one or more wires. This creates exposed conductors in the panel. A licensed electrician should evaluate further to determine any necessary improvements.

Bushings were missing where wires enter box. Bushings prevent wire damage from metal holes and this helps prevent electrical and fire hazards from wires shorting out.

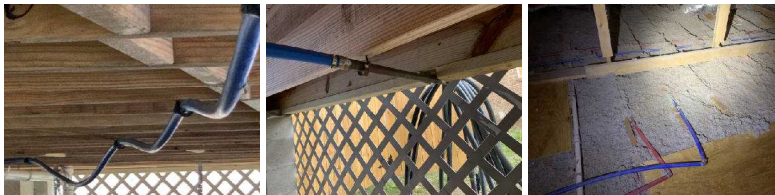
3. Marginal **Visible Supply Lines:** Plastic- pex type -

Pipes appeared to need additional support. Further evaluation by a licensed plumber is recommended.

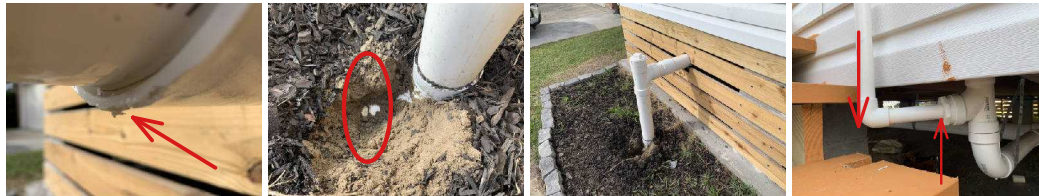
4. Defective **Visible Drain/ Waste Pipes:** PVC plastic -

The Main sewer/ drain pipe at the front of the house was leaking water during this inspection. The pipe moved excessively. It did not appear to be properly secured.

nonstandard instalation. This will promote drain clogging. Further evaluation by a licensed plumber is recommended.

Further evaluation by a licensed plumber is recommended.

Underground plumbing was not visible and could not be fully evaluated. For complete information regarding the concealed components, I recommend hiring a professional plumber with video equipment to evaluate further.

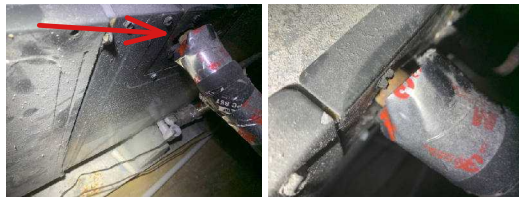
12. Defective

**Interior Refrigerant Line:** The entry point of lines were not sealed. This allows for the loss of conditioned air and the cold air rushing out into the hot attic builds condensation on the metal components. The water drips down and causes damage to the material or pan below. The cabinet should be sealed.

Noted water stains below.

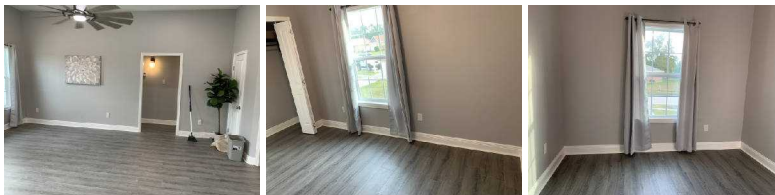
**Floor:** The floor did not appear to be level throughout. The structure did not appear to be level.

Further evaluation by a qualified contractor is recommended.

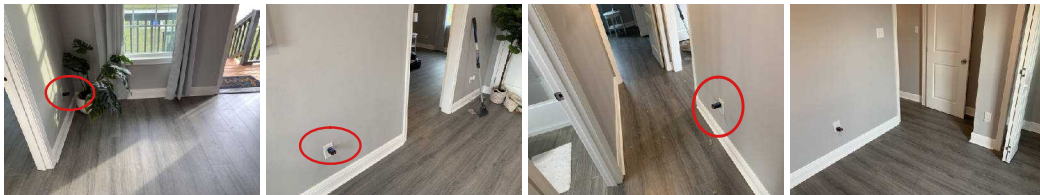
11. Defective

**Electrical Outlets:** Loose outlets noted, all should be properly secured to prevent electrical and fire hazards.

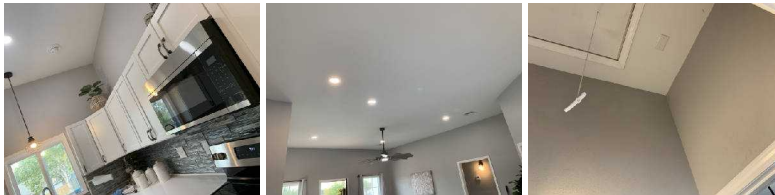
14. Not Inspected **Smoke/Carbon Detectors:** One or more detectors were present, Carbon Monoxide detectors could not be verified, Missing in areas -

Proper location could not be verified. Further evaluation and repair by a licensed contractor is recommended.

It is recommended that detectors are installed to meet current building standards. If additional detectors are necessary, they should be installed prior to move in. Batteries should be replaced and units tested during move in. Check all smoke detectors and replace all when 10 years old, or if age can not be determined.

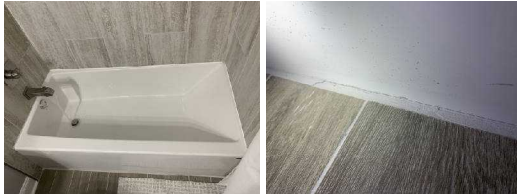
**Tub/Surround:** Tub surround needs silicone to prevent moisture buildup and damage between materials.

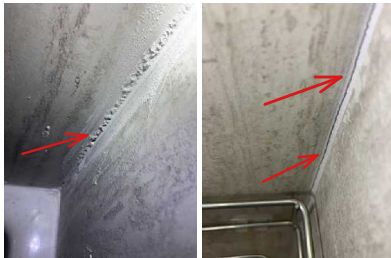
**Shower/Surround:** Loose or missing grout. The grout/ caulk at the seams has split open leaving a small gap. Moisture can enter and damage materials if not sealed tight. Any leaks or damage present were not visible during home inspection and would require a licensed contractor to evaluate further. Re-grout all areas necessary. A flexible sealant like polyurethane should be used in corners to help prevent leaks and damage.

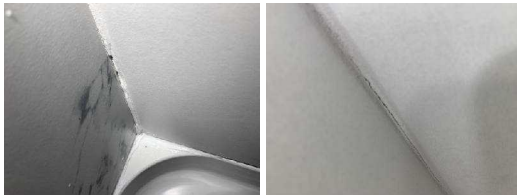
**Shower/Surround:** Loose or missing grout. The grout/ caulk at the seams has split open leaving a small gap. Moisture can enter and damage materials if not sealed tight. Any leaks or damage present were not visible during home inspection and would require a licensed contractor to evaluate further. Re-grout all areas necessary. A flexible sealant like polyurethane should be used in corners to help prevent leaks and damage.

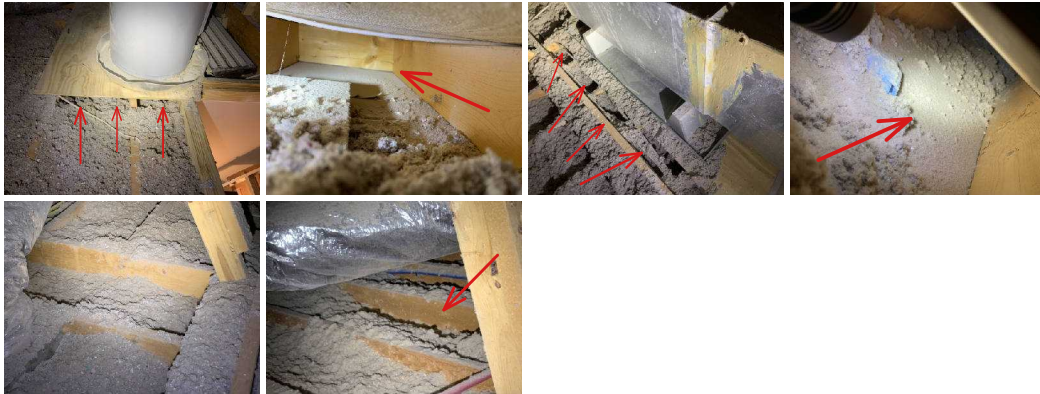
8. Defective **Insulation:** Loose cellulose -

Some areas have no insulation and others did not appear to be sufficient. The entire attic should be evaluated and necessary insulation should be installed as per current standards.

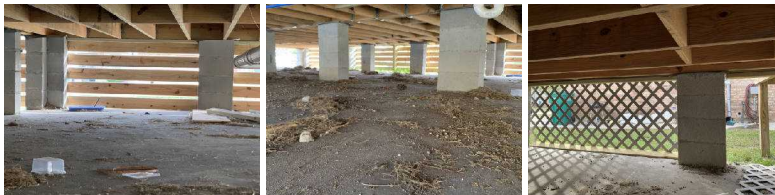
2. Marginal **Foundation:** Concrete, Concrete Block -

One or more areas appeared to be un level. Further evaluation and repair by a licensed contractor is recommended.

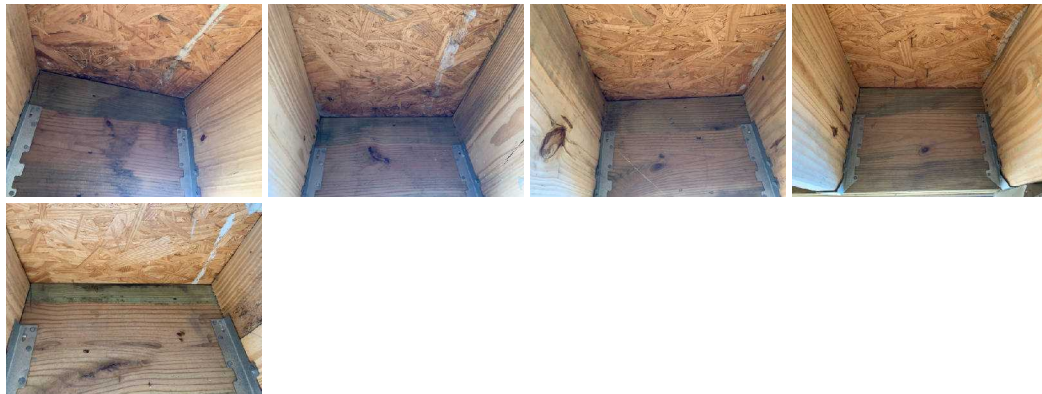
4. Defective

**Floor Material:** Wood subfloor, not visible -

Moisture stains and possible damage and organic growth noted. With questionable or missing flashing noted above, ongoing leaks and damage may occur.

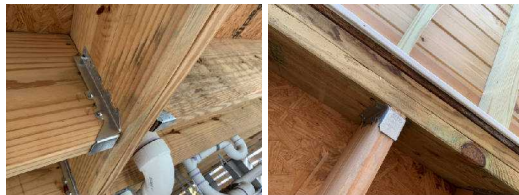
Moisture stains noted.

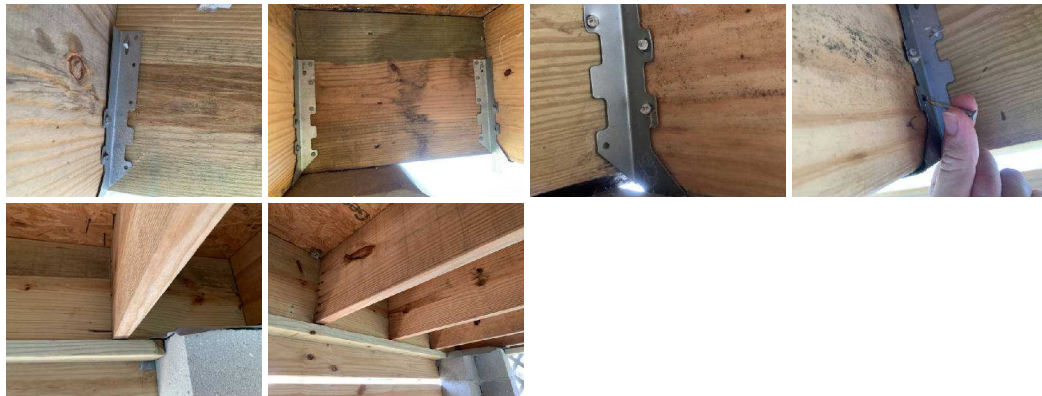
**Joists/Trusses:** Loose and missing components and hardware noted. Questionable hardware may be used in structural support brackets. One of the diagonal joist hanger nails pulled out by hand. It was an 8x1.5, which may not be sufficient. Joist hangers were missing. Further evaluation and repair by a licensed contractor is recommended.

Moisture stains partially visible. With questionable or missing flashing above noted, ongoing leaks and damage may occur.

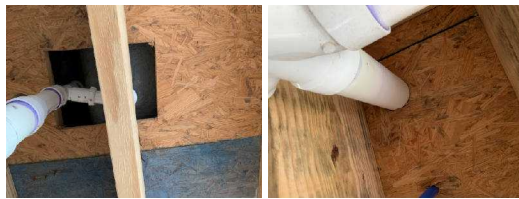
8. Defective

**Subfloor:** Penetrations and open gaps should be properly sealed for air control and to help eliminate entry of pest and insects.

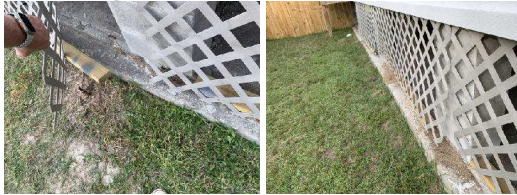
2. Defective

The crawlspace should be screened to prevent unauthorized entrance and damage by people, animal and pest. The space should remain vented.

Loose and improperly secured components noted.

Further evaluation and repair by a licensed contractor is recommended.
